### FINAL TARGETED SITE INVESTIGATION WORKPLAN, DECEMBER 2016, CRESCENT MILLS INDUSTRIAL SITE, PLUMAS COUNTY, CALIFORNIA

Project Name: DTSC Crescent Mills Project Number: SAC 147K Page 1 of 1  
Date: 2/6/17 Location: Crescent Mills, CA Logged By: P. Denny  
Weather Conditions: Cloudy, scattered rain, 40's-50's  
Tailgate Safety Meeting Time: 1030 Contractor: Cascade, Subtronic

| <p>GEOSYNTEC CONSULTANTS</p> <p>Photographic Record</p> | | <p>Geosyntec<br/>consultants</p> |

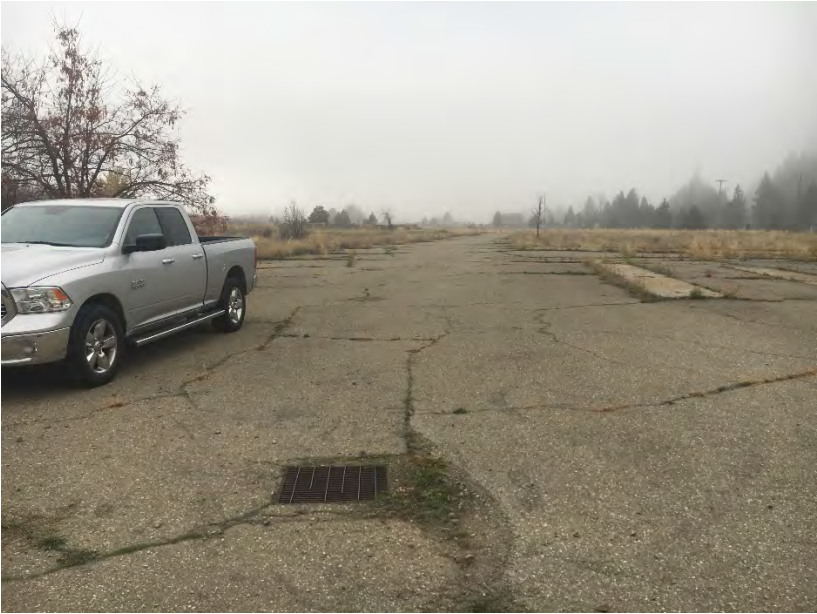
| <p>Photograph 1</p> | | |

| <p>Comments:</p> <p>Drop inlet along current mill road</p> | | |

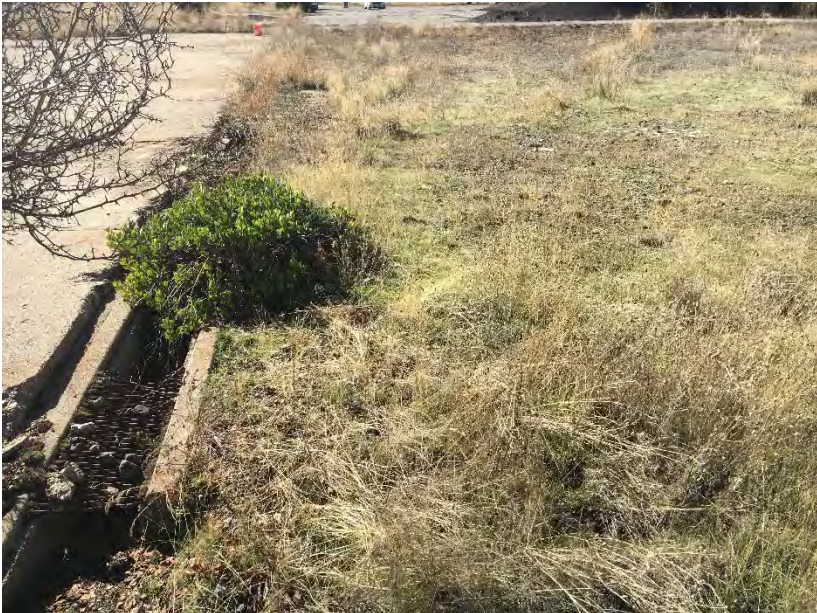
| <p>Photograph 3</p> <hr/> <p>Date:</p> <p>10 November 2016</p> <hr/> <p>Direction:</p> <p>South</p> <hr/> <p>Comments:</p> <p>Trench drain on west side of maintenance shop</p> | |

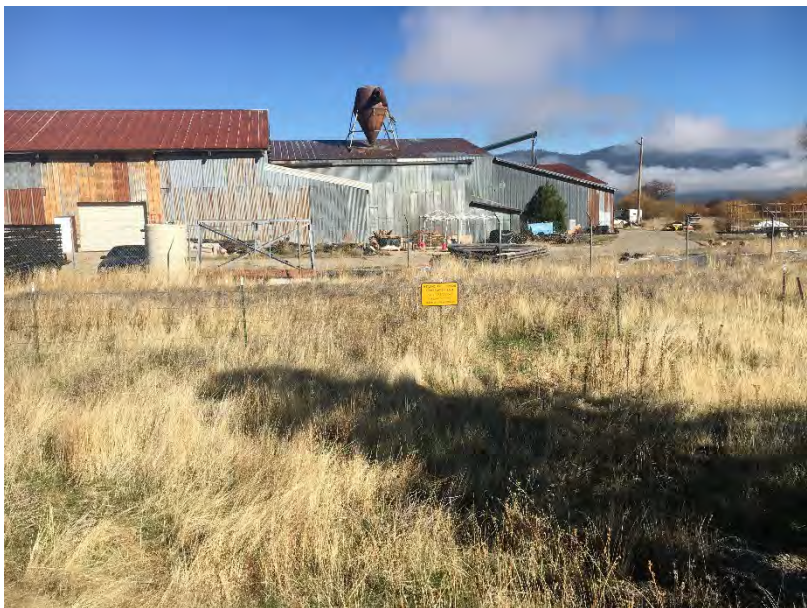
| <p>Photograph 4</p> <hr/> <p>Date:</p> <p>10 November 2016</p> <hr/> <p>Direction:</p> <p>North</p> <hr/> <p>Comments:</p> <p>Approximate location of former waste oil AST north of maintenance shop along northern property boundary. Sacramento Valley Moulding buildings shown in picture.</p> | |

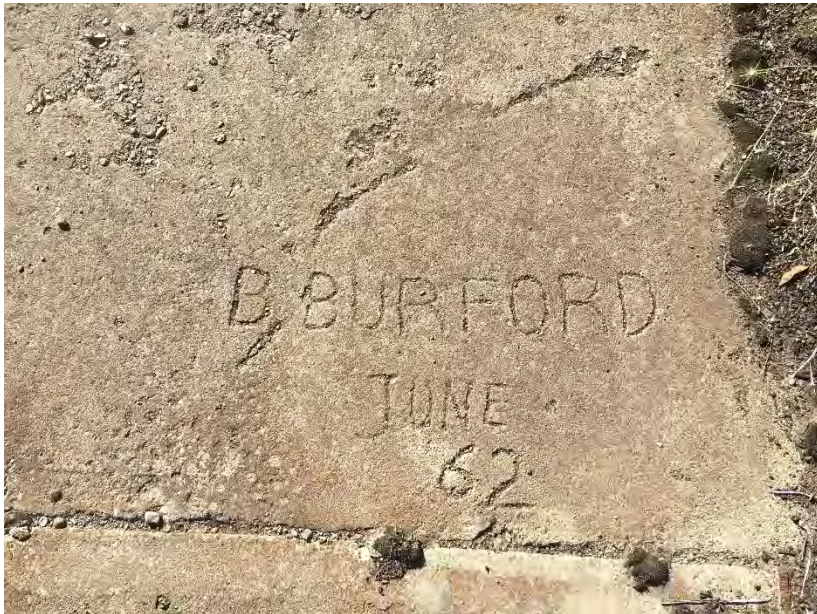
| <p>GEOSYNTEC CONSULTANTS</p> <p>Photographic Record</p> | | <p>Geosyntec<br/>consultants</p> |
|--|--|---|
| Photograph 5 | | |

| <p>GEOSYNTEC CONSULTANTS</p> <p>Photographic Record</p> | | <p>Geosyntec<br/>consultants</p> |
|--|--|---|
| Comments: Date of concrete foundation for dry lumber storage #4 – concrete foundation laid over former mill road | | |

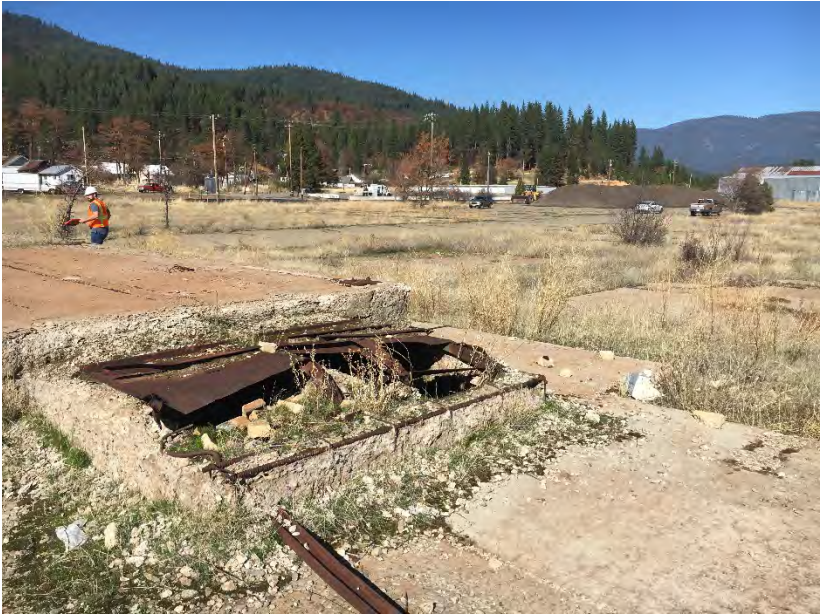
| <p>GEOSYNTEC CONSULTANTS</p> <p>Photographic Record</p> | | <p>Geosyntec<br/>consultants</p> |
|--|--|---|
| Photograph 7 | | |

| <p>GEOSYNTEC CONSULTANTS</p> <p>Photographic Record</p> | | <p>Geosyntec<br/>consultants</p> |
|--|--|---|
| Comments:<br>Former boiler | | |

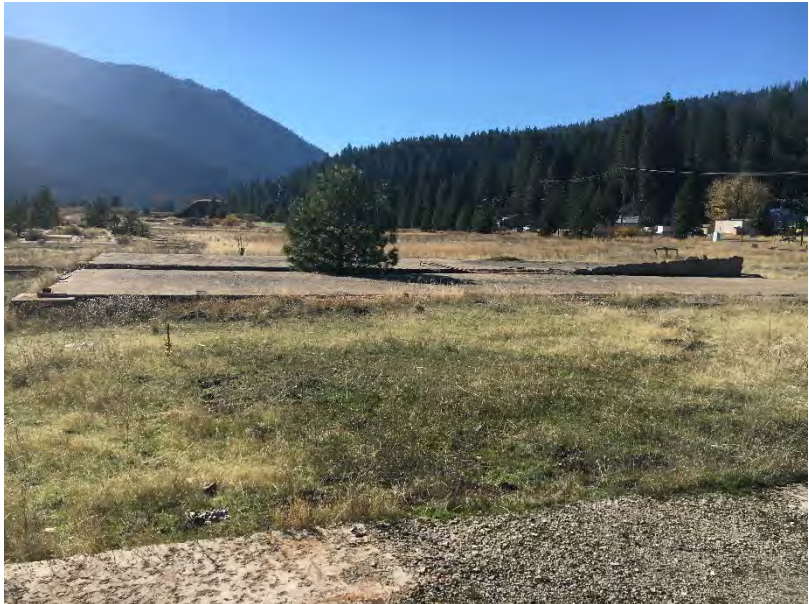
| <p>GEOSYNTEC CONSULTANTS</p> <p>Photographic Record</p> | | <p>Geosyntec<br/>consultants</p> |
|--|--|---|
| Photograph 8 | | |

| <p>GEOSYNTEC CONSULTANTS</p> <p>Photographic Record</p> | | <p>Geosyntec<br/>consultants</p> |
|--|--|---|
| Comments:<br>Former boiler fuel shed<br>foundation and ramp that<br>was lower to left and<br>higher to right of photo. | | |

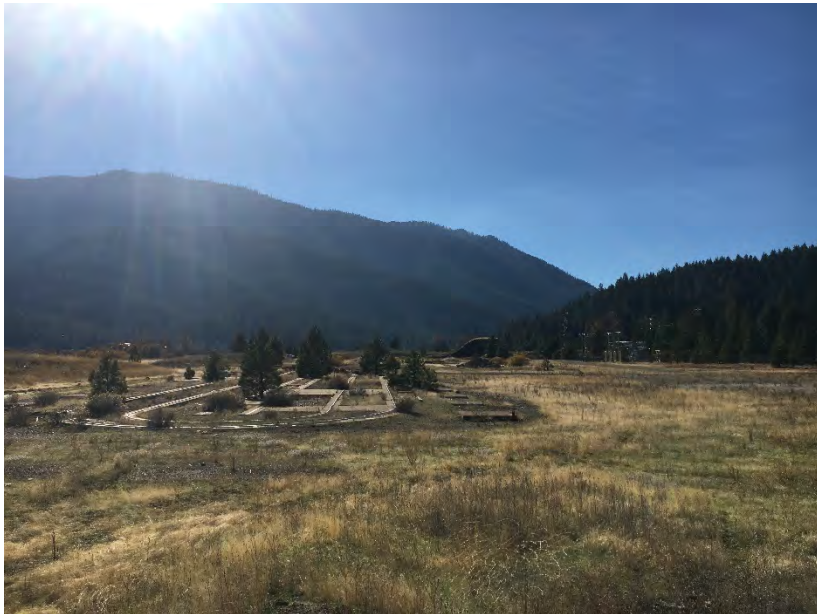
| <div> <div>GEOSYNTEC CONSULTANTS</div> <div>Photographic Record</div> <div> <div>Geosyntec</div> <div>consultants</div> </div> </div> | |
|--|--|
| <div>Photograph 9</div> <div>Date:</div> <div>10 November 2016</div> <div>Direction:</div> <div>South</div> <div> <div>Comments:</div> <div>Former sorter/stacker building</div> </div> | |

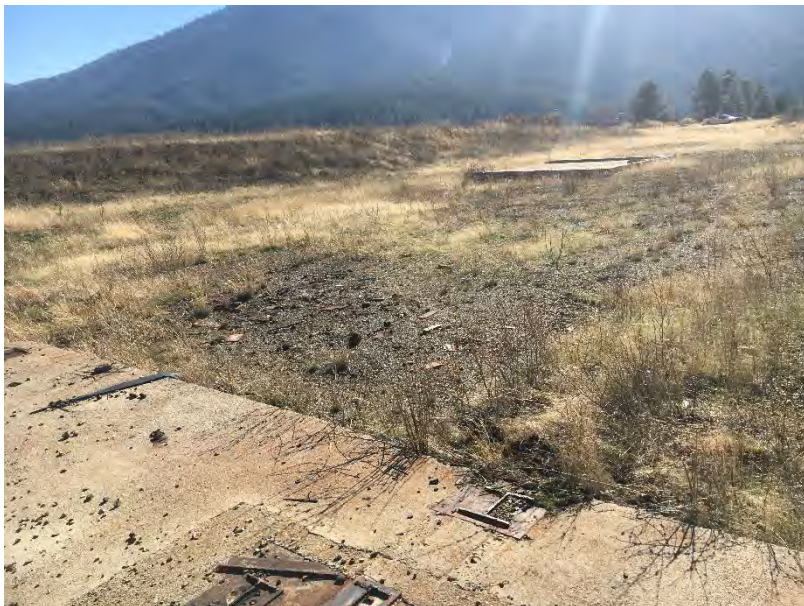
| <div> <div>GEOSYNTEC CONSULTANTS</div> <div>Photographic Record</div> <div> <div>Geosyntec</div> <div>consultants</div> </div> </div> | |
|--|--|
| <div>Photograph 10</div> <div>Date:</div> <div>10 November 2016</div> <div>Direction:</div> <div>South</div> <div> <div>Comments:</div> <div>Dead vegetation and construction debris including sprayer nozzle between sorter/stacker building, green chain (pictured), and saw mill (to right).</div> </div> | |

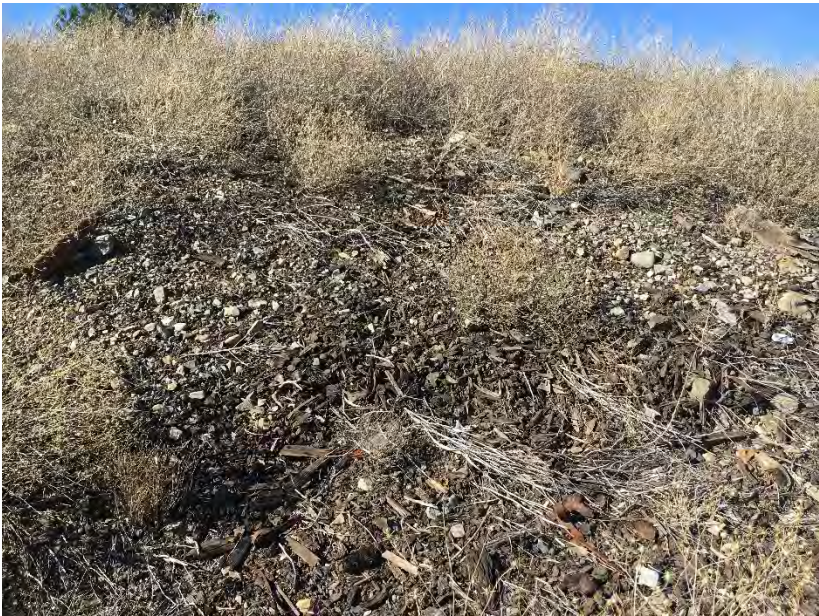
| <p>Photograph 13</p> <hr/> <p>Date:</p> <p>10 November 2016</p> <hr/> <p>Direction:</p> <p>West</p> <hr/> <p>Comments:</p> <p>Typical wood waste and fill stockpile #2 materials.</p> | | |

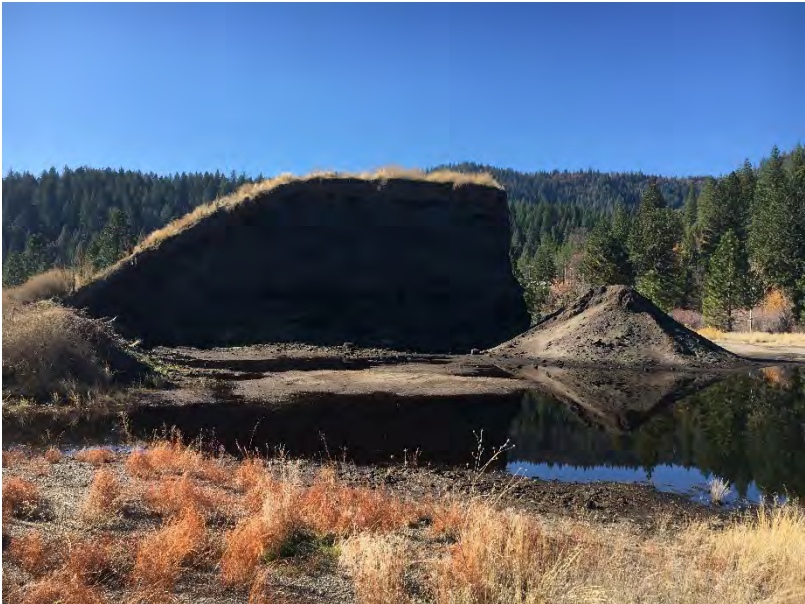
| <p>Photograph 14</p> <hr/> <p>Date:</p> <p>10 November 2016</p> <hr/> <p>Direction:</p> <p>West</p> <hr/> <p>Comments:</p> <p>Wood waste stockpile #5. DU-19 was collected on left side of pile shown in photo.</p> | | |

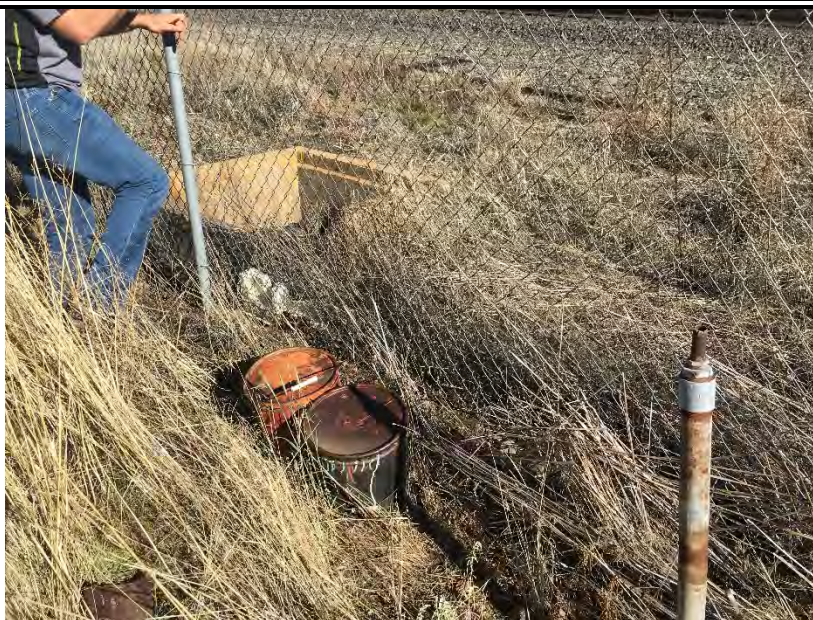
Comments:  
Cans of unidentified  
substances, possibly  
paint, along the western  
property boundary near  
the Old Dry Kiln.

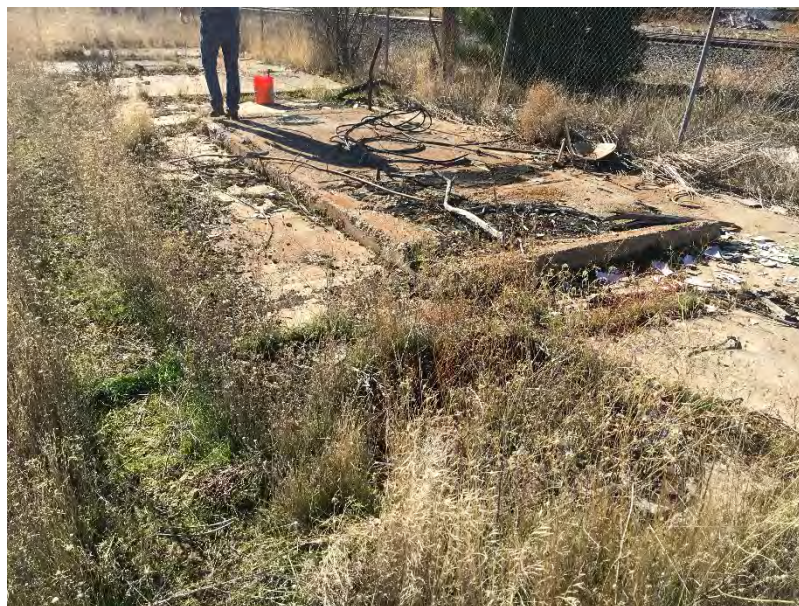
Photograph 18

Comments:  
Above ground piping  
associated with Old Dry  
Kiln. Sample SB-13  
collected to east of  
location.

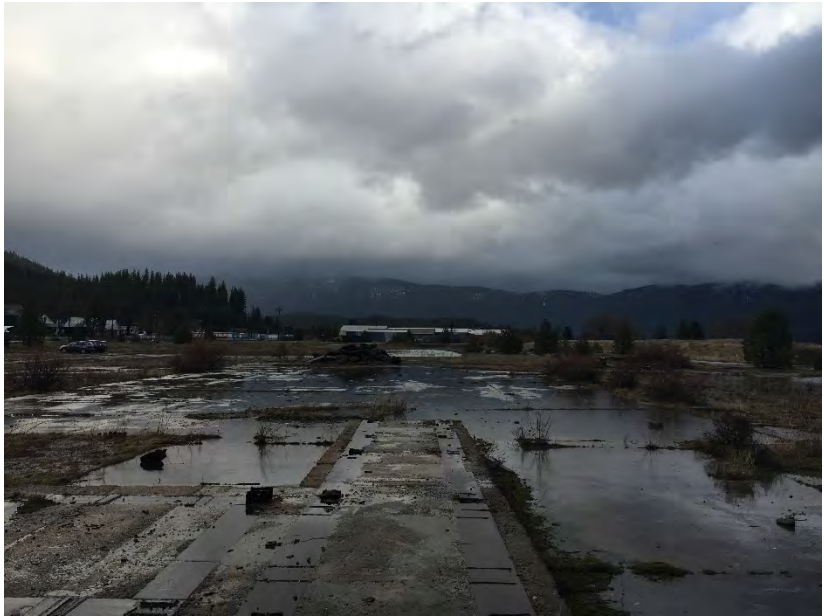
| <p>GEOSYNTEC CONSULTANTS</p> <p>Photographic Record</p> | | <p>Geosyntec<br/>consultants</p> |
|--|--|---|
| Photograph 19 | | |

| <p>GEOSYNTEC CONSULTANTS</p> <p>Photographic Record</p> | | <p>Geosyntec<br/>consultants</p> |
|--|--|---|
| Pooling water at former saw mill. | | |

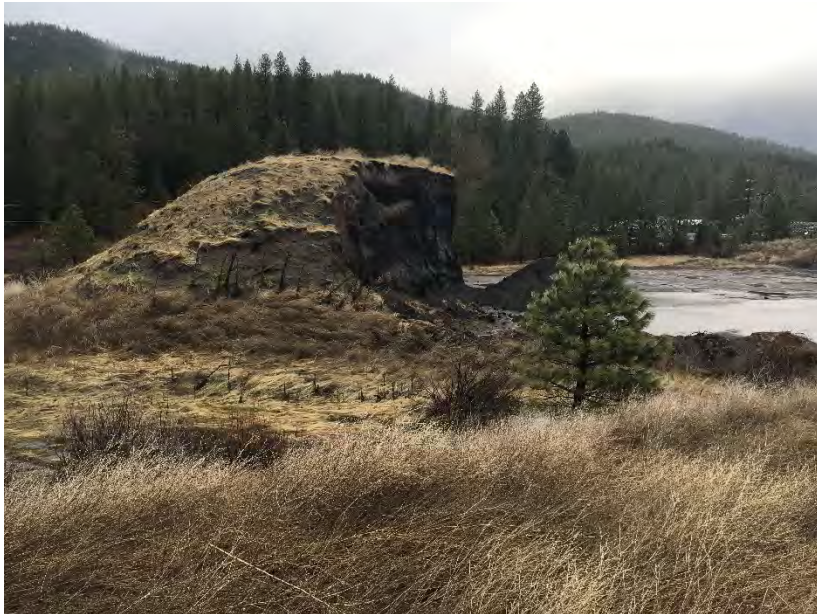
| <p>GEOSYNTEC CONSULTANTS</p> <p>Photographic Record</p> | | <p>Geosyntec<br/>consultants</p> |
|--|--|---|
| <p>Photograph 21</p> | | |

| <p>GEOSYNTEC CONSULTANTS</p> <p>Photographic Record</p> | | <p>Geosyntec<br/>consultants</p> |
|--|--|---|
| <p>Comments: Wood waste stockpile #5. DU-19 collected on left side of pile.</p> | | |

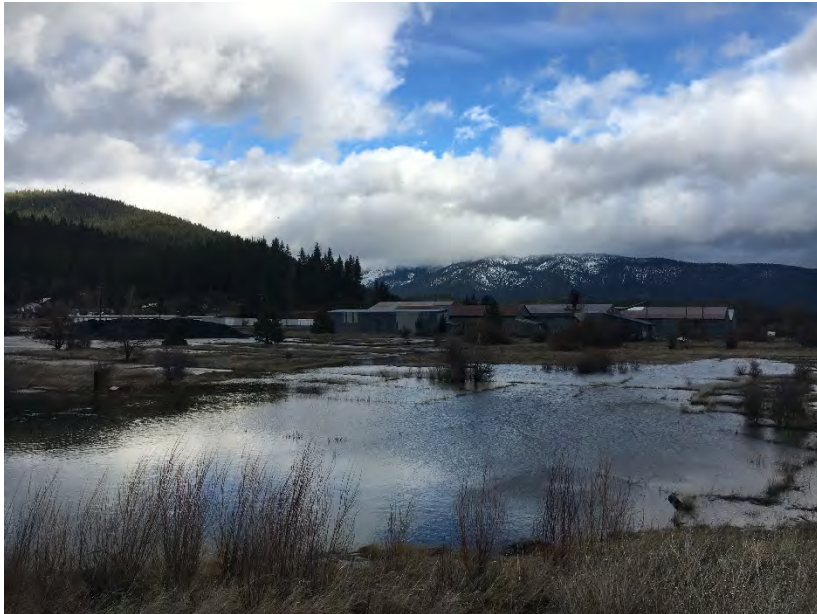
| <p>Photograph 23</p> <hr/> <p>Date:</p> <p>6 February 2017</p> <hr/> <p>Direction:</p> <p>Northwest</p> <hr/> <p>Comments:</p> <p>Site flooding between new planing mill and maintenance shop as seen from wood waste and fill stockpile #2.</p> | |

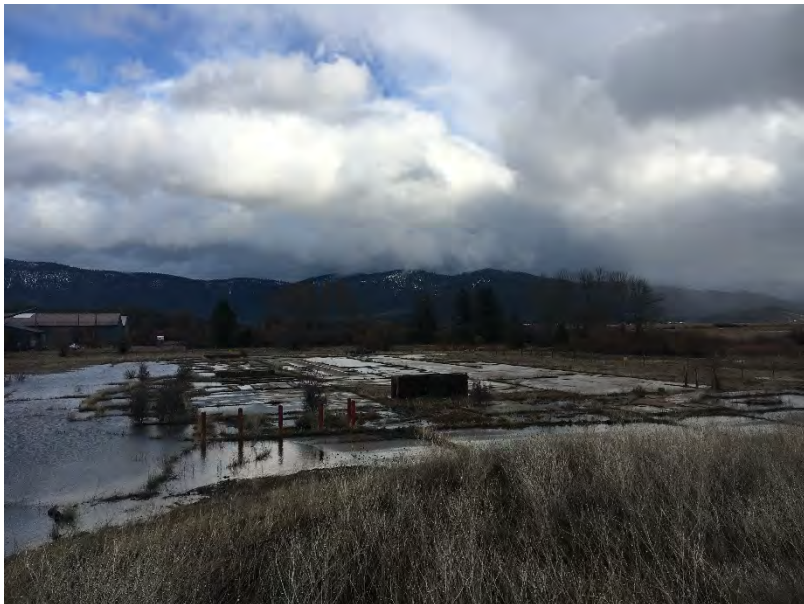
| <p>Photograph 24</p> <hr/> <p>Date:</p> <p>6 February 2017</p> <hr/> <p>Direction:</p> <p>North</p> <hr/> <p>Comments:</p> <p>Location of SB-11 and SB-12 at new planing mill, east of the extent of flooding.</p> | |

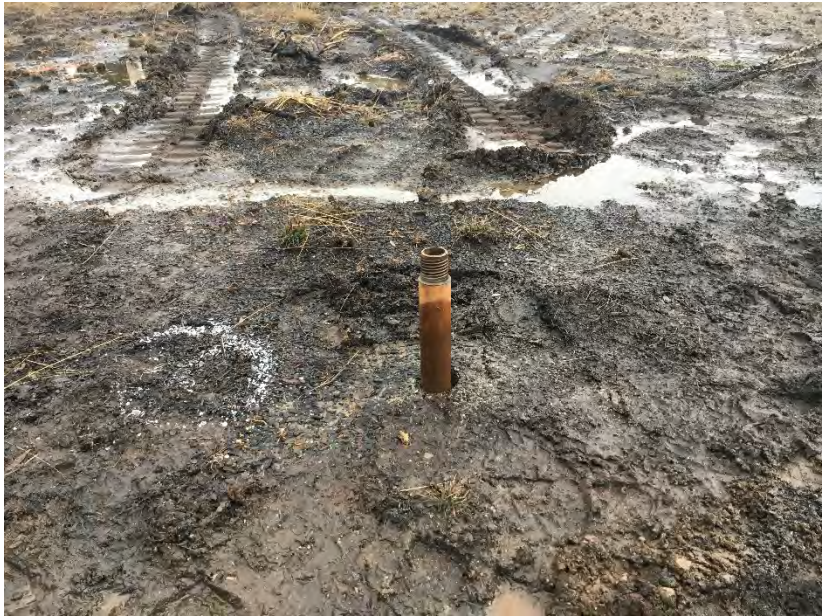
| <p>Photograph 25</p> <p>Date:</p> <p>6 February 2017</p> <p>Direction:</p> <p>North</p> <p>Comments:</p> <p>Typical casing left in ground for groundwater sampling.</p> | |

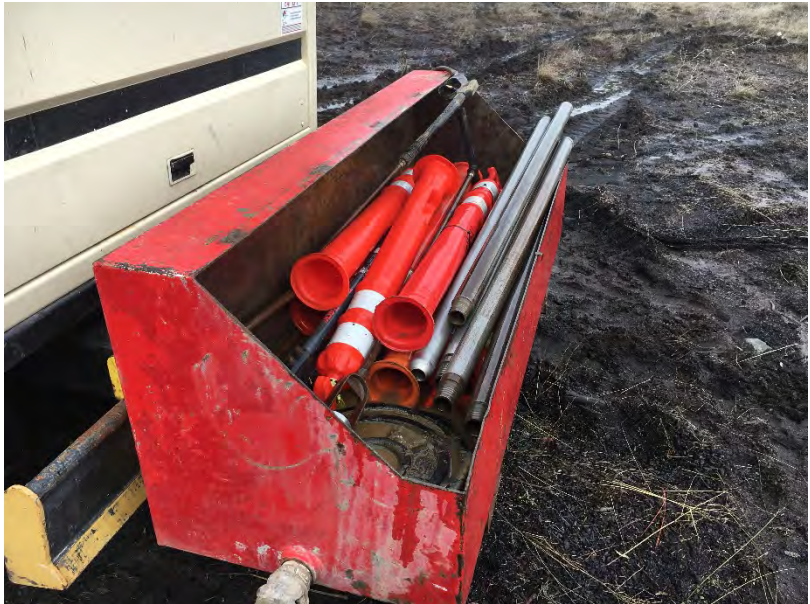
| <p>Photograph 26</p> <p>Date:</p> <p>6 February 2017</p> <p>Direction:</p> <p>North</p> <p>Comments:</p> <p>Pressure washer setup for drilling rod decontamination.</p> | |

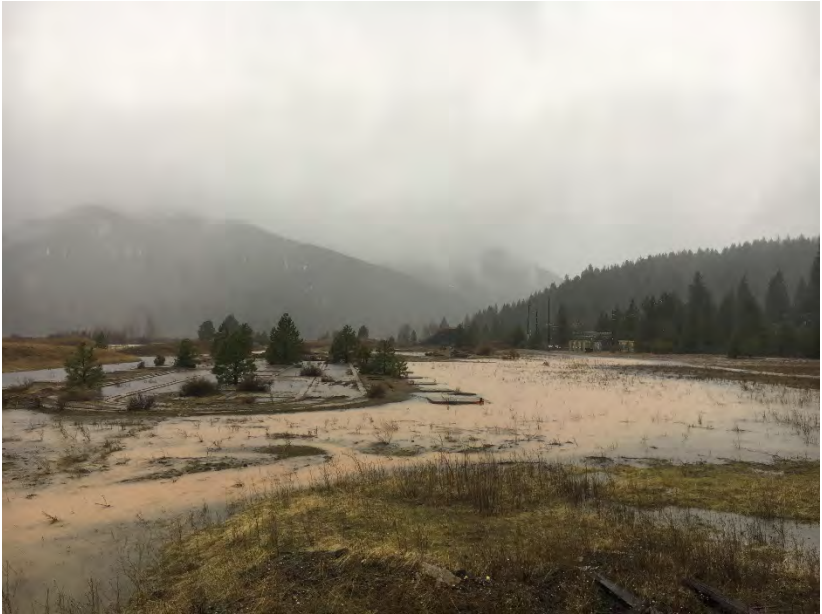
| <p>GEOSYNTEC CONSULTANTS</p> <p>Photographic Record</p> | | <p>Geosyntec<br/>consultants</p> |
|--|--|---|
| Photograph 31 | | |

| <p>GEOSYNTEC CONSULTANTS</p> <p>Photographic Record</p> | | <p>Geosyntec<br/>consultants</p> |
|--|--|---|
| Flooding in the sorter stacker area in late afternoon on 9 February. | | |

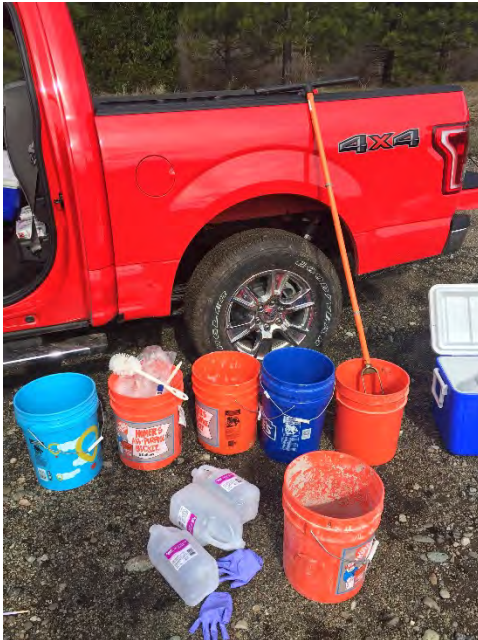
| <p>GEOSYNTEC CONSULTANTS</p> <p>Photographic Record</p> | | <p>Geosyntec<br/>consultants</p> |
|---|--|---|
| <p>Photograph 35</p> <p>Date:</p> <p>26 March 2017</p> <p>Direction:</p> <p>NA</p> <p>Comments:</p> <p>Three bucket wash decontamination system for hand auger used in sampling.</p> | | |

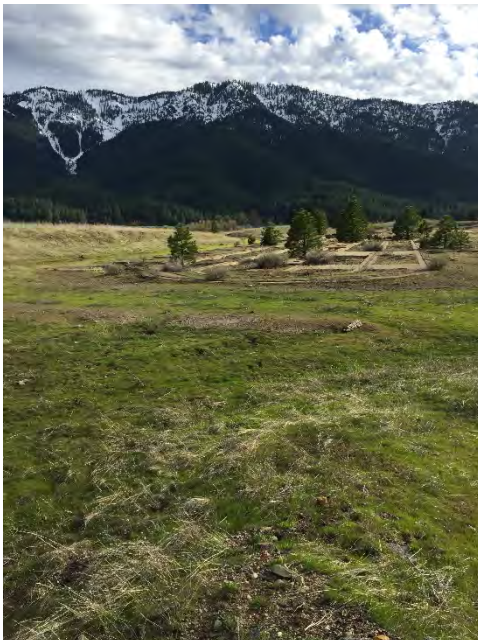
| <p>GEOSYNTEC CONSULTANTS</p> <p>Photographic Record</p> | | <p>Geosyntec<br/>consultants</p> |
|---|--|---|
| <p>Photograph 36</p> <p>Date: 26 March 2017</p> <p>Direction:</p> <p>South</p> <p>Comments:</p> <p>General condition of the Saw Mill and Sorter/Stacker area. Water from February flooding had receded.</p> | | |

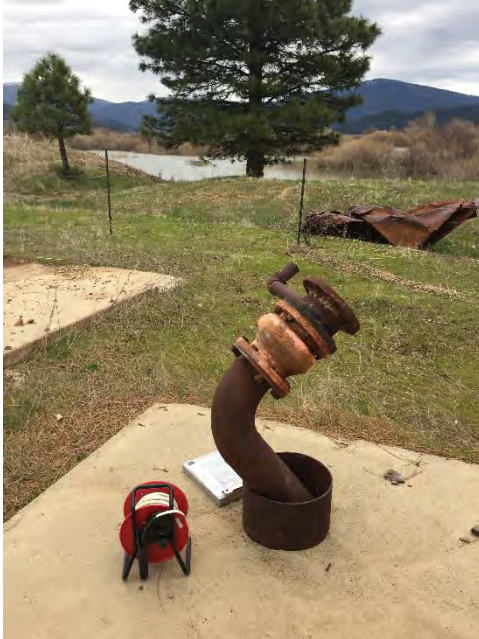
| <p style="text-align: center;">GEOSYNTEC CONSULTANTS</p> <p style="text-align: center;">Photographic Record</p> | | <p style="text-align: right;">Geosyntec<br/>consultants</p> |
|---|--|---|
| <p>Photograph 37</p> <p>Date:</p> <p>26 March 2017</p> <p>Direction:</p> <p>East</p> <p>Comments:</p> <p>Log deck water supply well. The water level and depth to the bottom of the well were measured using the water level meter shown.</p> | | |

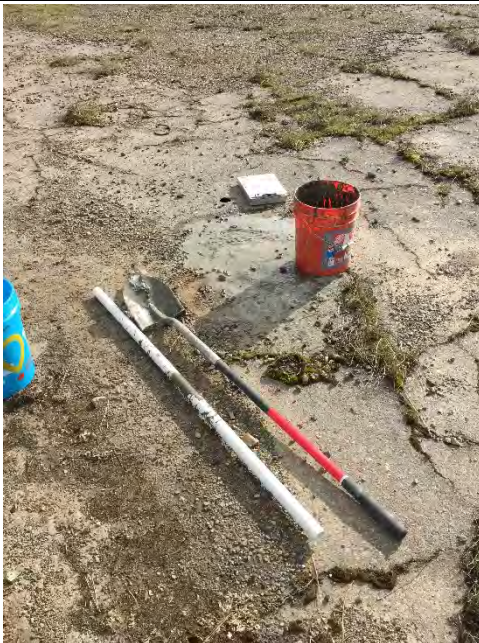
| <p style="text-align: center;">GEOSYNTEC CONSULTANTS</p> <p style="text-align: center;">Photographic Record</p> | | <p style="text-align: right;">Geosyntec<br/>consultants</p> |
|---|--|---|
| <p>Photograph 38</p> <p>Date: 26 March 2017</p> <p>Direction:</p> <p>NA</p> <p>Comments:</p> <p>Poured grout through tremie pipe into borings that could be located that were not sealed prior to Site flooding during initial investigation.</p> | | |

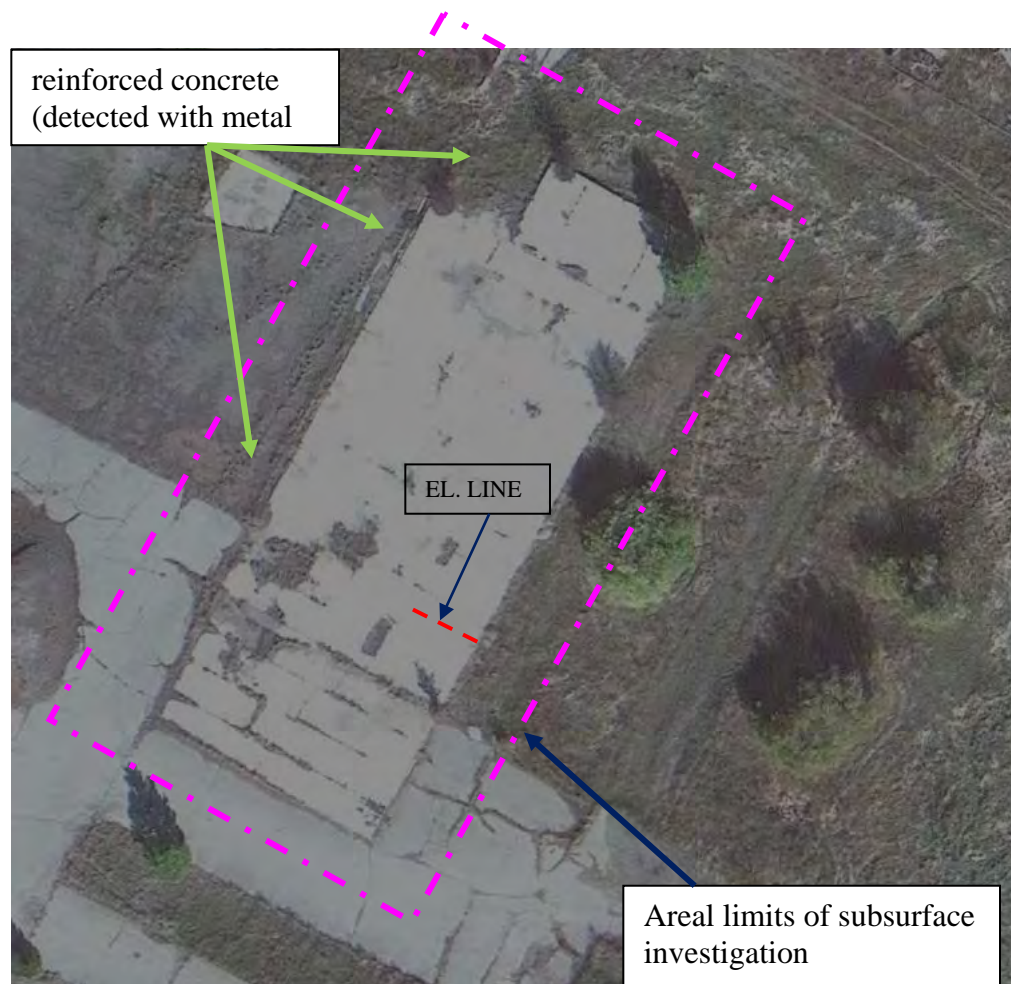
A visual inspection of the site indicated several pipe risers. Most of the pipe risers were interpreted to be abandoned electric lines. The electric lines traced to the center of the concrete slab. This suggests that they were installed for machinery located in the center of the shop. A 4 inch cast iron sewer riser was found in the northeast corner of the slab, it was traced southeastward toward the empty field.

The figure below shows the limits of the subsurface survey and the electric line previously discussed. Also shown on this map is reinforced concrete detected during the metal detection scan.

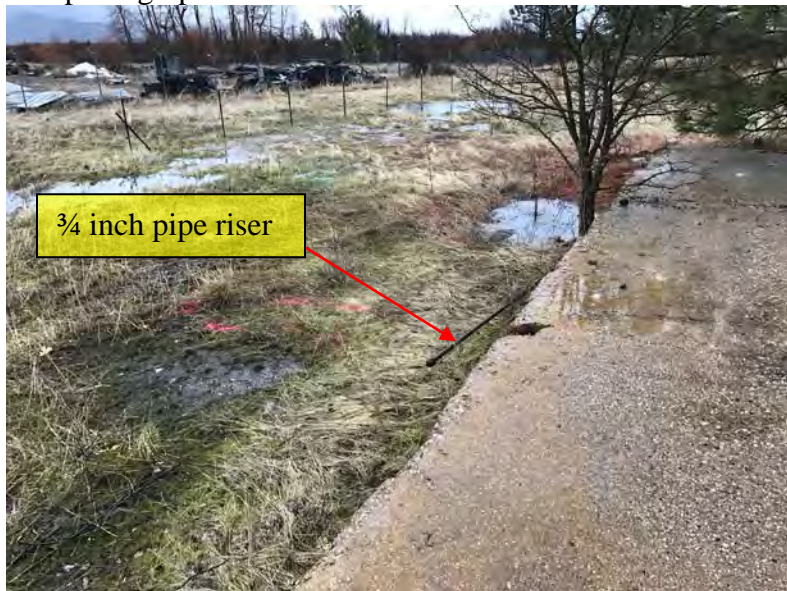
The photograph below shows a 3/4 in riser.
